Buildings 776 and 777 Closeout Briefing Summary

Prepared by Rik Getty

Rev 0 (12/05)

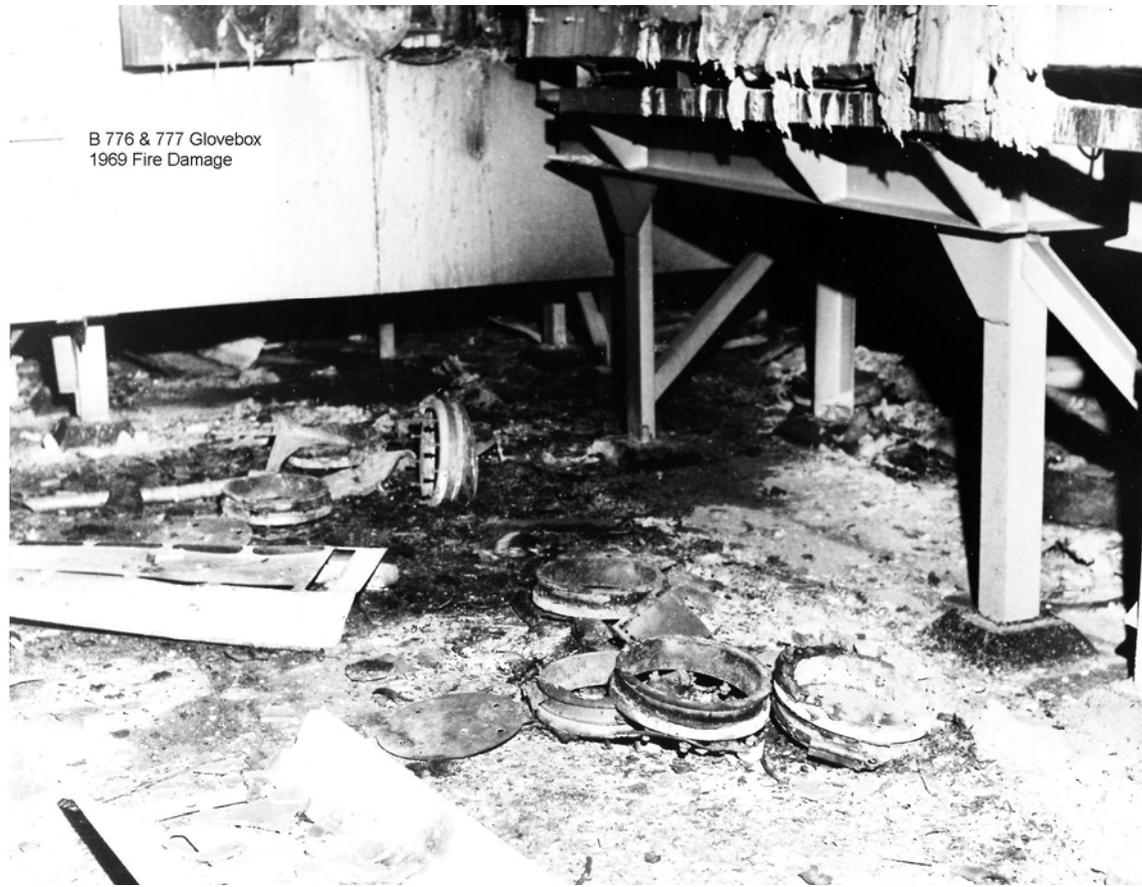
In 1969 a catastrophic fire inside 776/777 caused extensive damage to the operating equipment and building structure (see Figure 2, page 6, for example of typical glovebox fire damage). The fire started inside a glovebox when a Pu briquette spontaneously ignited. A Pu briquette was scrap Pu metal from machining operations that was collected and compressed into a "briquette". The fire breached the glovebox system and spread to surrounding areas resulting in extensive Pu contamination throughout 776/777. Small amounts of Pu were released to the surrounding environment around 776/777 as a result of the fire and fire-fighting actions. Initial decontamination clean-up activities in 776/777 were not completed until 1971. Due to the nature of the Pu contamination from the fire, the facility could never be decontaminated to Pu contamination levels that existed before the fire. As a result of the fire the site incorporated safety measures into future Pu operations and a new facility, Building 707, was brought on-line in 1972 for Pu fabrication operations with many Pu fire safety upgrades compared to 776/777.

Figure 2. Photo showing damage to a glovebox after 1969 fire.

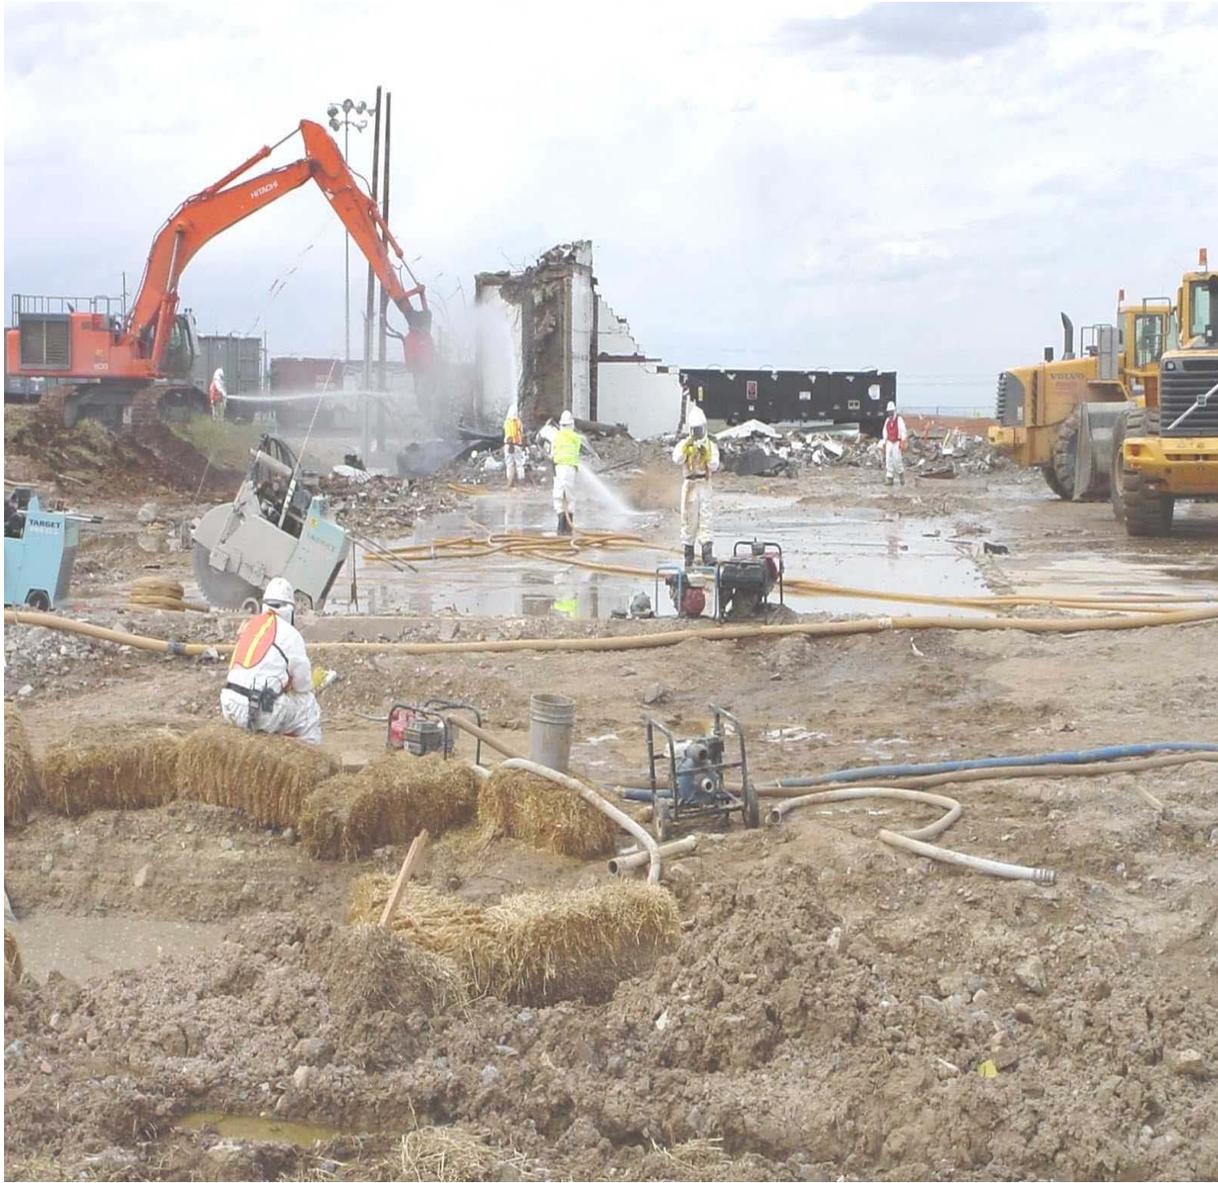
Figure 3. Photo (May 2005) of last section of 776/777 being demolished. Note use of dust suppression measures and railcars in background

The site removed a large inventory of both hazardous and radioactive waste prior to the actual building demolition and remediation. Pu contamination was decontaminated to the extent practical as overseen and approved by the regulators, but not all contamination could be removed. After the decontamination effort reached a certain level, the regulators determined that the remaining contamination could stay in place resulting in the remaining building structure being declared low level radioactive waste (LLW). Areas with remaining contamination were protected by various fixatives and the building was carefully demolished using heavy equipment. Dispersal of airborne contamination was kept to a minimum using water-based fogs and sprays. Water from this airborne suppression effort was collected in holding ponds for subsequent analysis prior to any treatment or free-release. Debris waste from 776/777 was loaded onto specialized railcars for shipment to the LLW waste disposal site at Envirocare of Utah (see Figure 3, page 7, showing the last section of 776/777 being demolished).
