Buildings 771 and 774 Closeout Briefing Summary

Prepared by Rik Getty

Rev 0 (12/05)

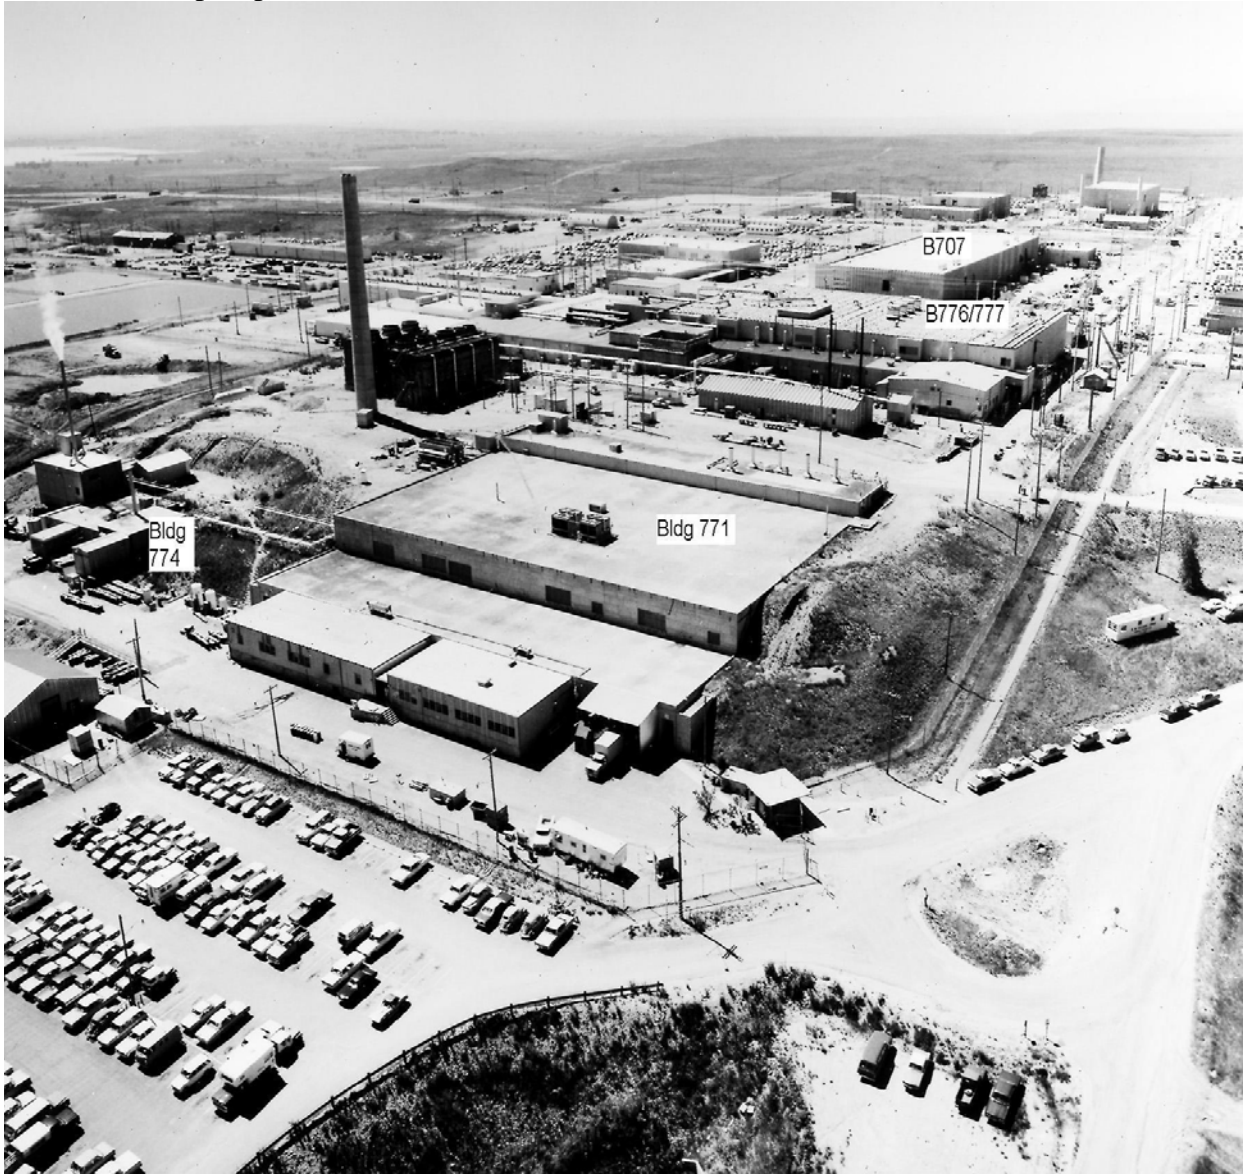
Figure 1. Aerial view of 771 in 1969 looking to south

Note: As can be seen 771 was built into a hillside; 774 is the smaller complex to the left (east) of 771. This photo also shows Buildings 776, 777, and 707 located to the south (towards the top of photo) of 771.

Building 771 (B771) construction began in 1951 and operations began in May, 1953. The original designation for B771 was Plant C or 71. After quite a few years the designation changed to 771 just like the original Plant A or 44 became B444 as more and more buildings were added to the site. The original building was a two-story structure built into the side of a hill with most of three sides covered by earth (see Figure 1, page 7). The fourth side, facing north, provided the main entrance to the building.

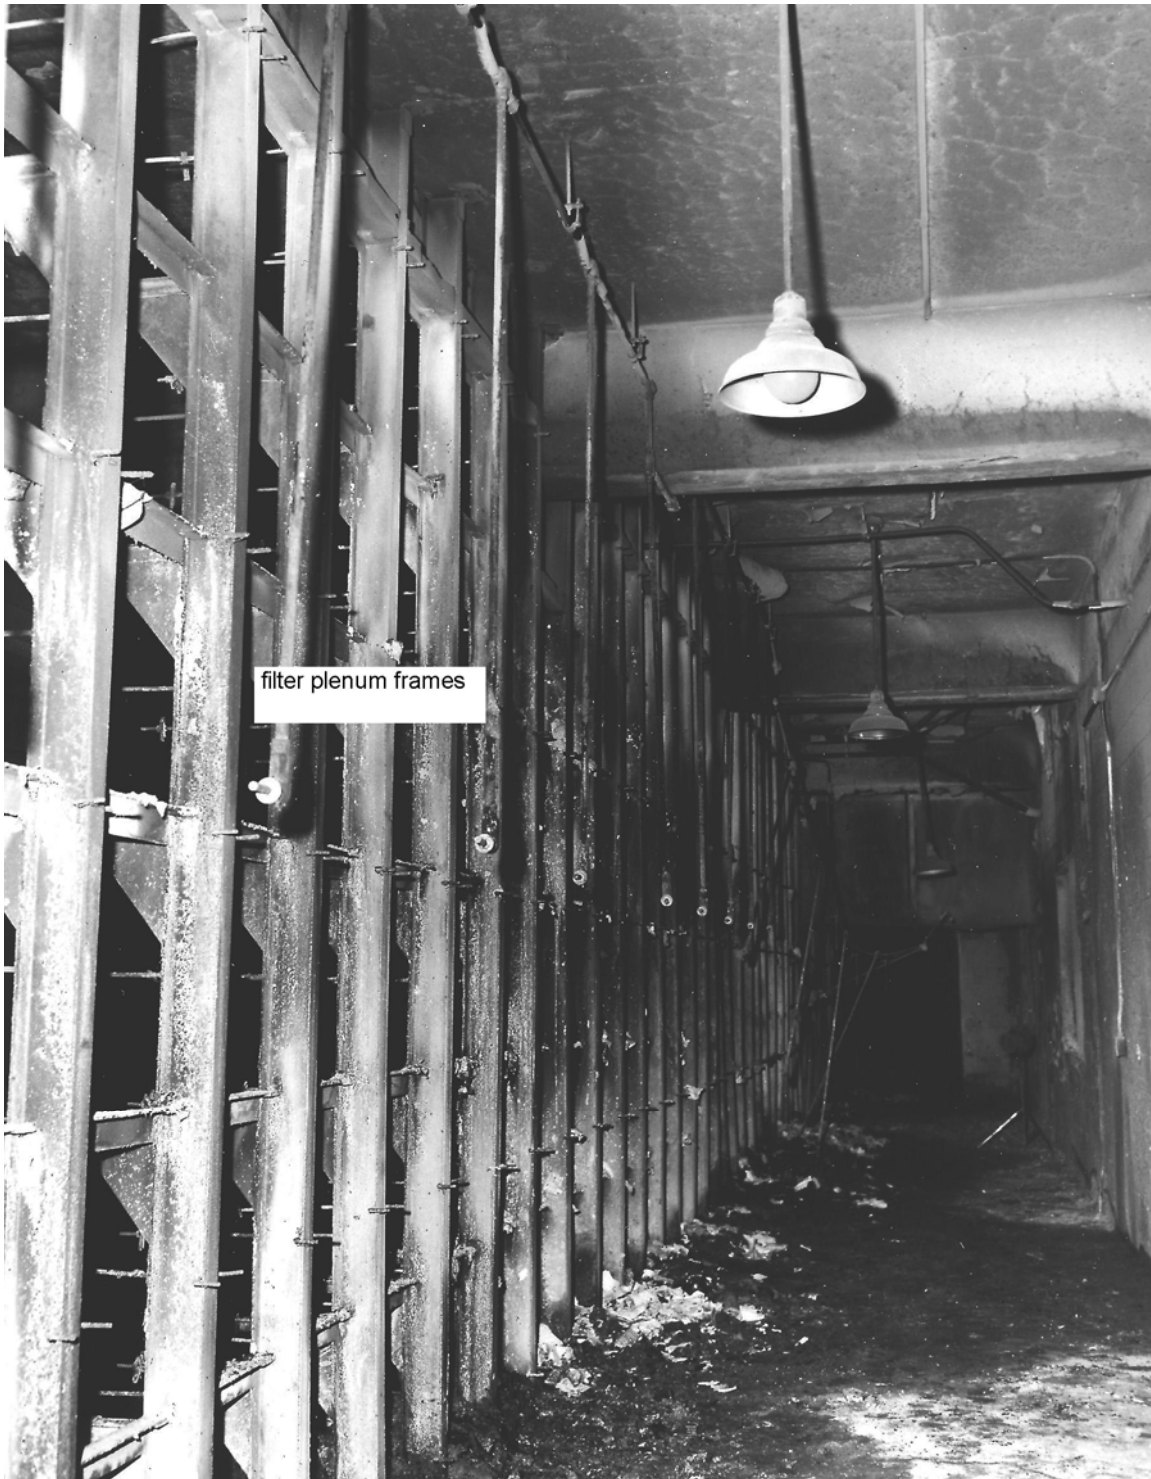
Figure 2. View of filter plenums damaged from fire in 771(9/16/57)

Note: the filter plenums were used to filter glovebox and process equipment atmospheres to remove Pu prior to exhausting to outside air. Some Pu escaped from 771 when the filter plenums were severely damaged by the fire.

The foundry operations consisted of casting Pu metal into forms that could be fabricated for assembly into nuclear warhead components. In 1957 these operations were transferred to B776/777 after a fire caused major damage to 771 (see Figure 2, page 8, for 771 fire damage).

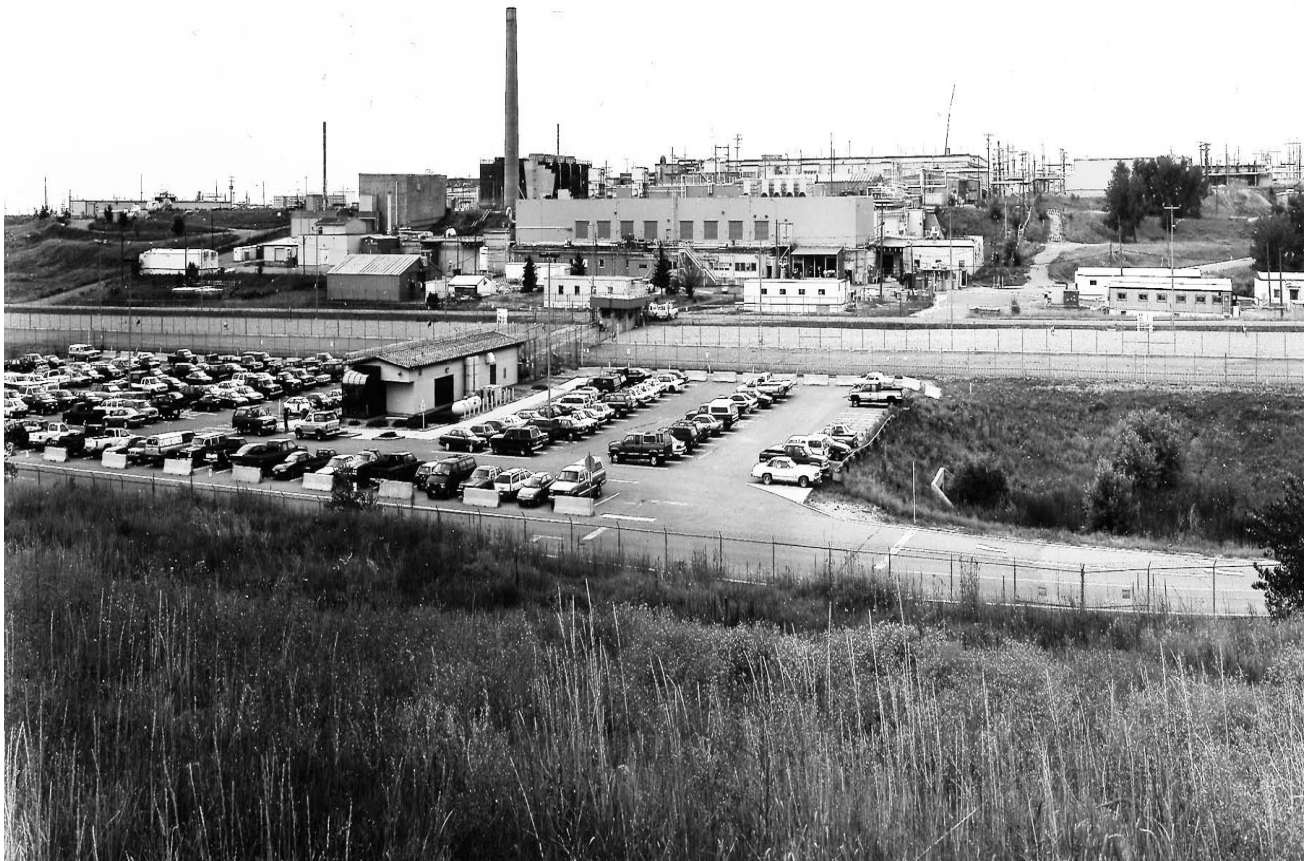
Figure 3. View of 771/774 complex in early 1990's looking south

The final grade was established using the backfill materials then erosion control matting was added to the hillside and the area was revegetated with hydromulch containing native seed species. The revegetation was completed in the late summer/early fall of 2004. Before and after photos of 771/774 can be seen in Figures 3 and 4 (pages 9 & 10).

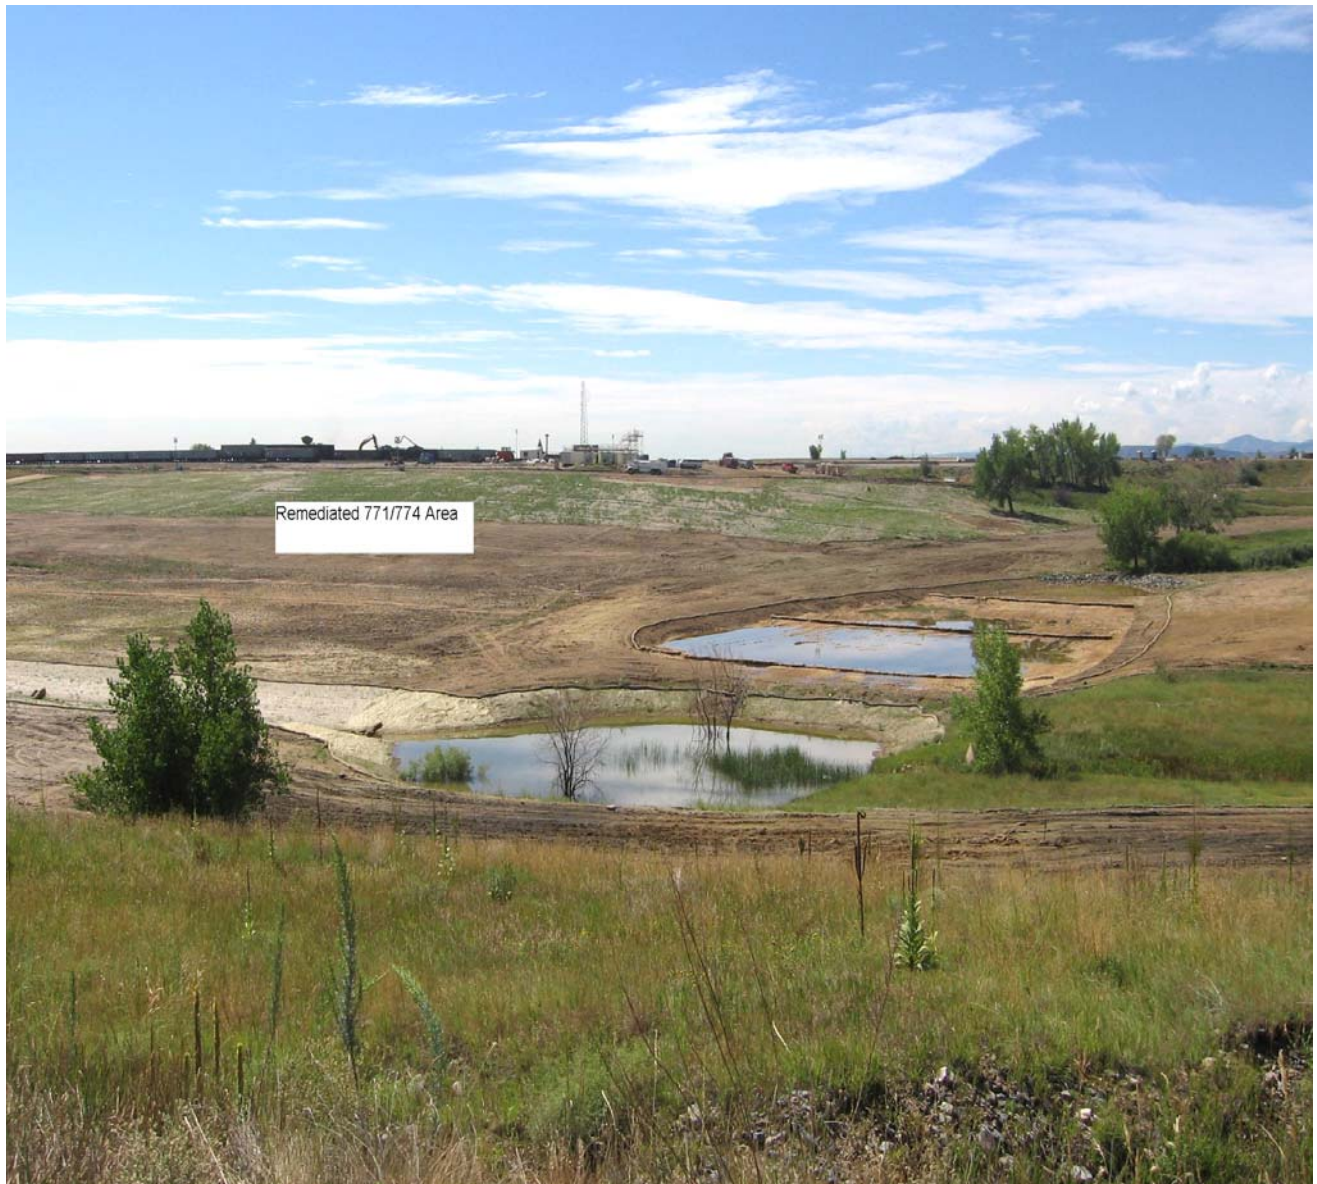
Figure 4. View looking south from August 2005 showing completed remediation of 771/774 at approximately the same location as Figure 3. Note: new wetlands have been added to the area and at the top of the slope one can see railroad cars being loaded with low level radioactive debris waste from the demolition of B776/777. These specialized railroad cars will carry the debris waste to the low-level radioactive waste disposal site, Envirocare of Utah.
