ROCKY FLATS STEWARDSHIP COUNCIL

Monthly Status Report – January 2010

Rocky Flats Project Takes Advantage of Required Maintenance to Improve Performance

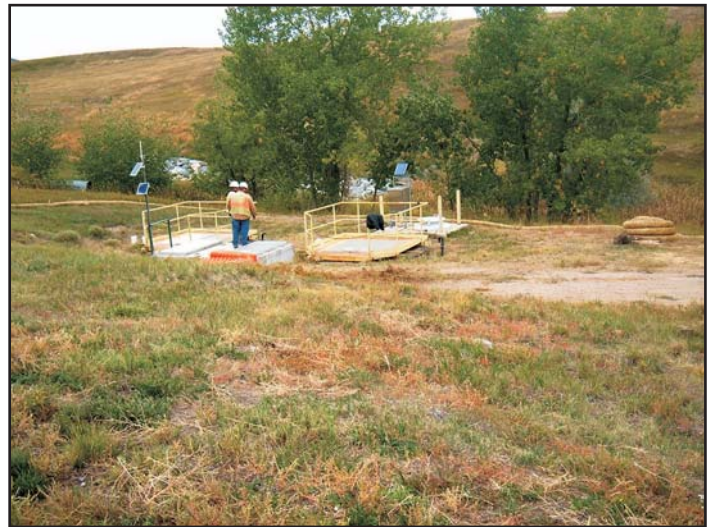
The East Trenches Plume Treatment System prior to the media replacement project.

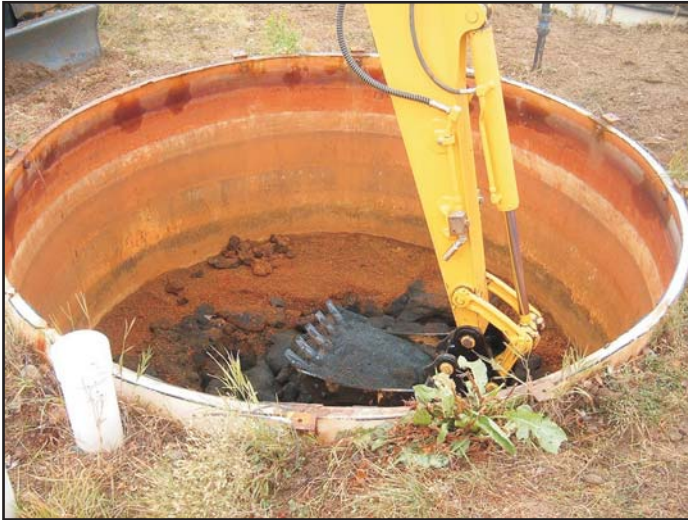
During media removal you can see the mineralized ZVI that has become crusted and turned orange, while the black ZVI in the center of the cell shows little sign of contact with water flow.

During the ETPTS media replacement project, site personnel discovered that the water had been bypassing a significant portion of the media, causing some portions of the media to mineralize and block the flow of water to other portions. Because the water would then flow around those blocked portions rather than flowing through the media evenly, some of the media had little contact with the contaminated water and the effectiveness of the treatment was reduced. In addition, mineralized media can adhere to the cell walls, requiring a jack hammer to remove it.

“series, down-flow” configuration promoted solidification of the media at the top of each cell, which forced the water to flow downward along the sides of the cell, bypassing media in the center of the cell.

To reduce the potential for flow to shortcut through or around the media, the predominant flow configuration is now “up-flow,” with water entering at the base of each cell and exiting at the top. Furthermore, because when operated in series, the media in the first cell becomes clogged much more quickly than that in the second, the system is now operated primarily in a “parallel” flow configuration: the influent water now flows into the bottom of both cells in parallel, rising through the media as the cell fills and exits out the top of the cells. Additionally, the media configuration was redesigned so that the lowermost several feet of media in each cell consists of thin, alternating layers of gravel and ZVI. This is intended to more gradually remove the dissolved constituents (predominantly calcium, iron, and carbonate) that cause clogging and promote a more even flow through the pure ZVI media above the layered media.

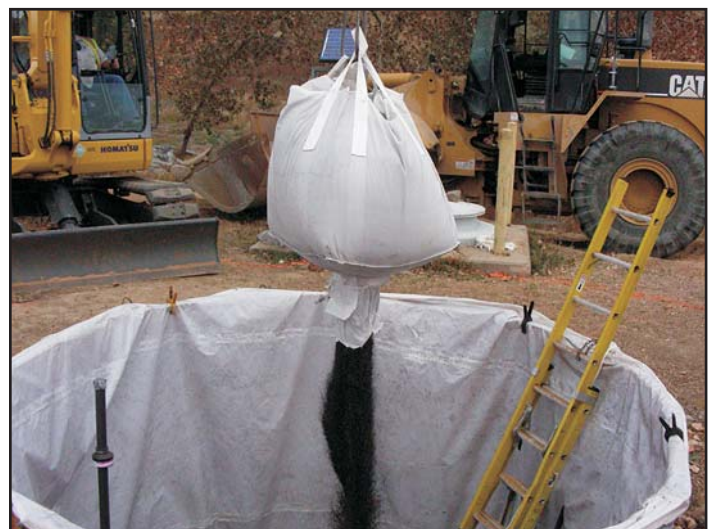
New ZVI media is placed into one of the treatment cells. The new liner in the cell is also visible.

useful life of the media. The total thickness of the media was also increased. This media design and up-flow operation also eliminates the time-consuming maintenance requirement to rake the top of the media on a weekly basis.

Finally, a liner was installed in each cell to prevent the media from adhering to the cell walls, easing future media replacement efforts.

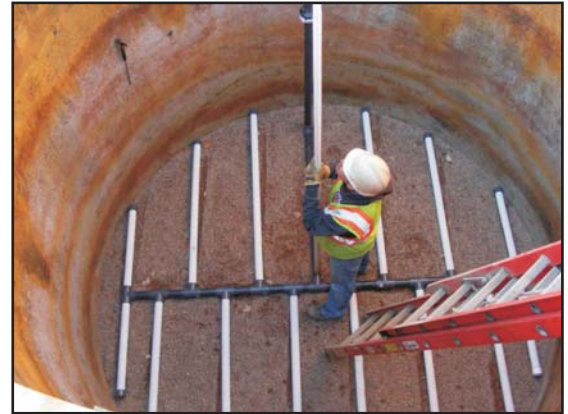
A contractor installs the plumbing that distributes the water to be treated in the cell.

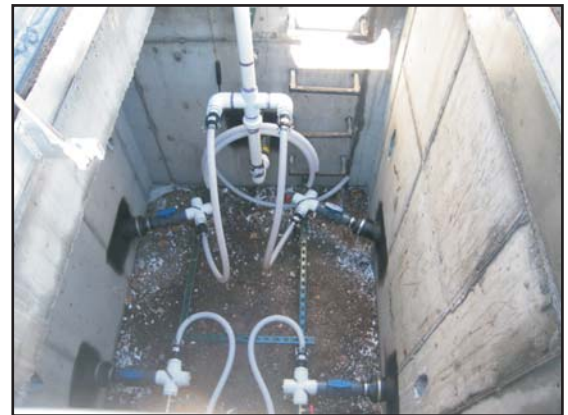
A feature of the new vault installed as part of the system improvements is that the plumbing configuration can be easily changed and new pipe liners installed.

The redesign also included replacing the existing plumbing adjacent to and between the treatment cells. Originally the pipes and some valves were buried underground, which requires a relatively large excavation and trench boxes in order to repair pipes or reconfigure valves. The new design incorporated an additional vault to act as the central valve box and pipe liners that will allow the liners to be easily replaced from within the vault when the pipes start to clog with mineralization.

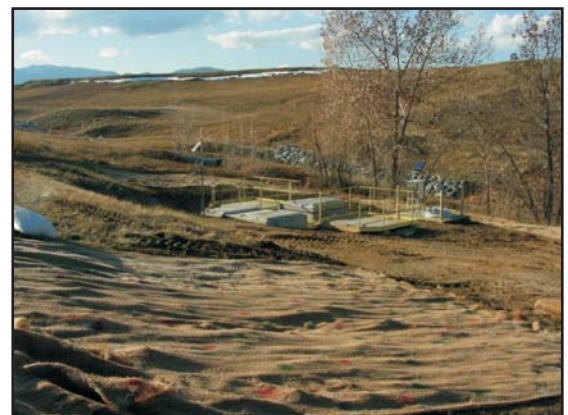
The newly installed vault is visible between the cells at the completion of the media replacement project.
