Buildings 371 and 374 (371/374) Closeout Briefing Summary

Prepared by Rik Getty

Rev 0 (12/05)

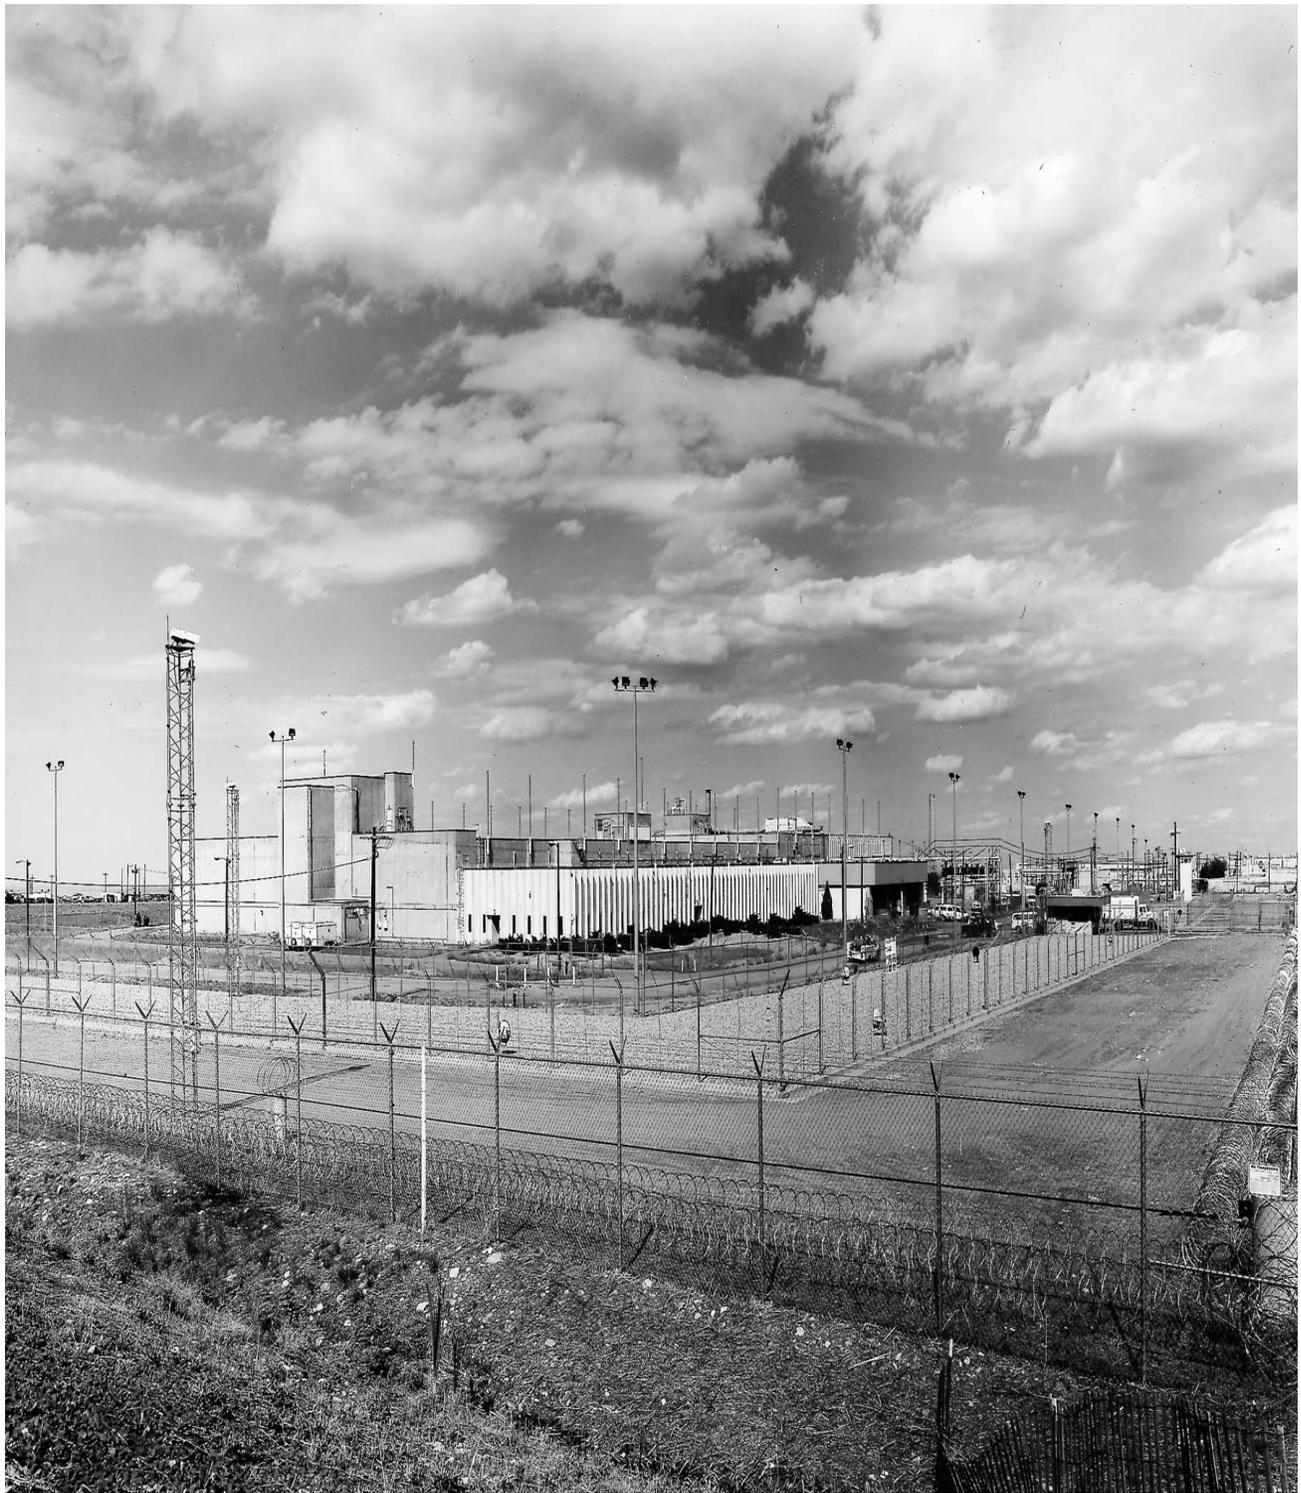
Figure 1. Photo of 371/374 (circa 1980's) looking Northeast. A large portion of 371 was below grade, the basement and sub-basement. 374 also had a basement but no sub-basement. 374's location was about the eastern 1/3 of the 371/374 footprint. Also note the high-security perimeter security zone (PSZ) features in the photo.

371 was a 4-level structure constructed of heavily reinforced concrete built to withstand design-basis tornados and earthquakes (see Figure 1, page 5). Its 315,000 ft² consisted of the main floor (ground level) housing most of the Pu operations, a small attic containing utilities, a basement (same basic footprint as main floor) containing air filtration and other process equipment, and a smaller sub-basement.

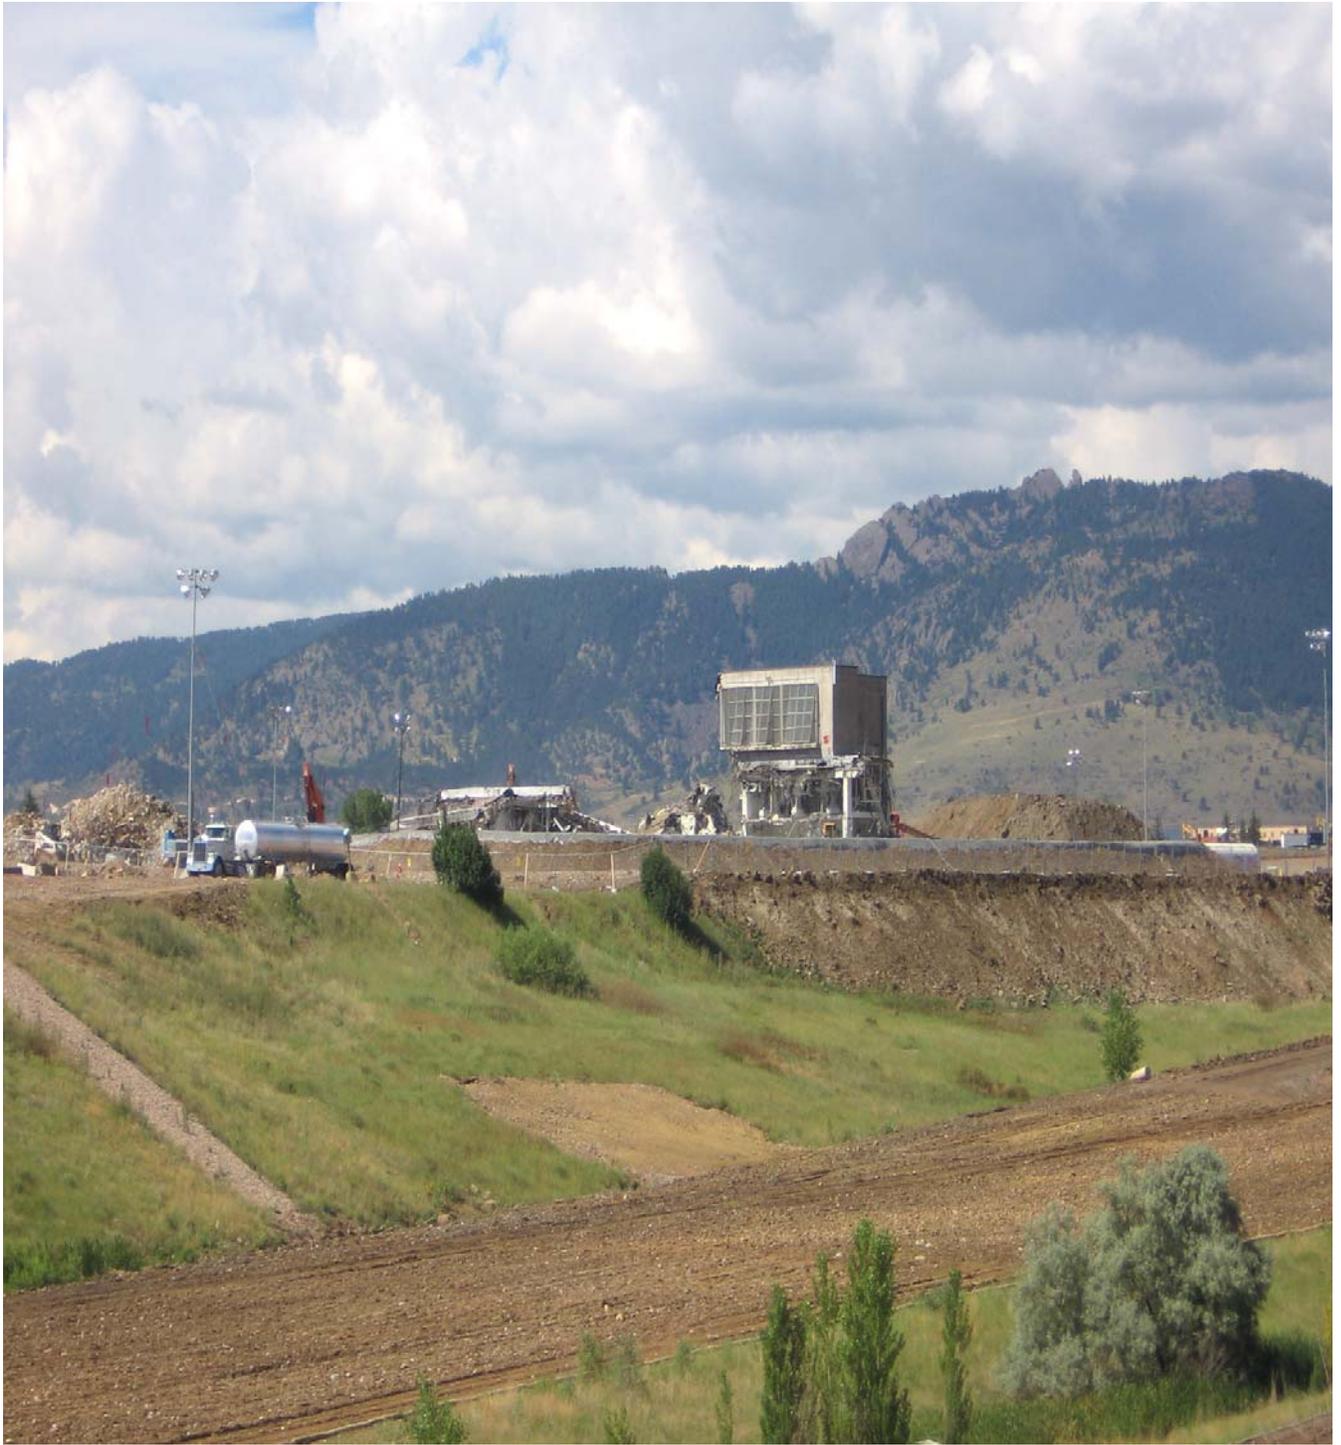
Figure 2. Photo from August 2005 looking southwest at the final demolition stage of 371/374 main floor.

Figure 2, page 6, is a photo from August 2005 showing the last remaining section of the 371 main floor undergoing demolition. 371/374 was remediated, re-graded, and re-vegetated by September 2005 – about 67,000 m³ of clean backfill was used to achieve the final land configuration. The 371/374 remedial action helped the site achieve early physical closure on October 13, 2005, instead of the projected December 16, 2006, contractual physical closure date estimate.
