Mound Site IHSS Briefing Summary

Briefing Summary Revision Number

Rev 0 (12/05)

IHSS 113, Mound Site

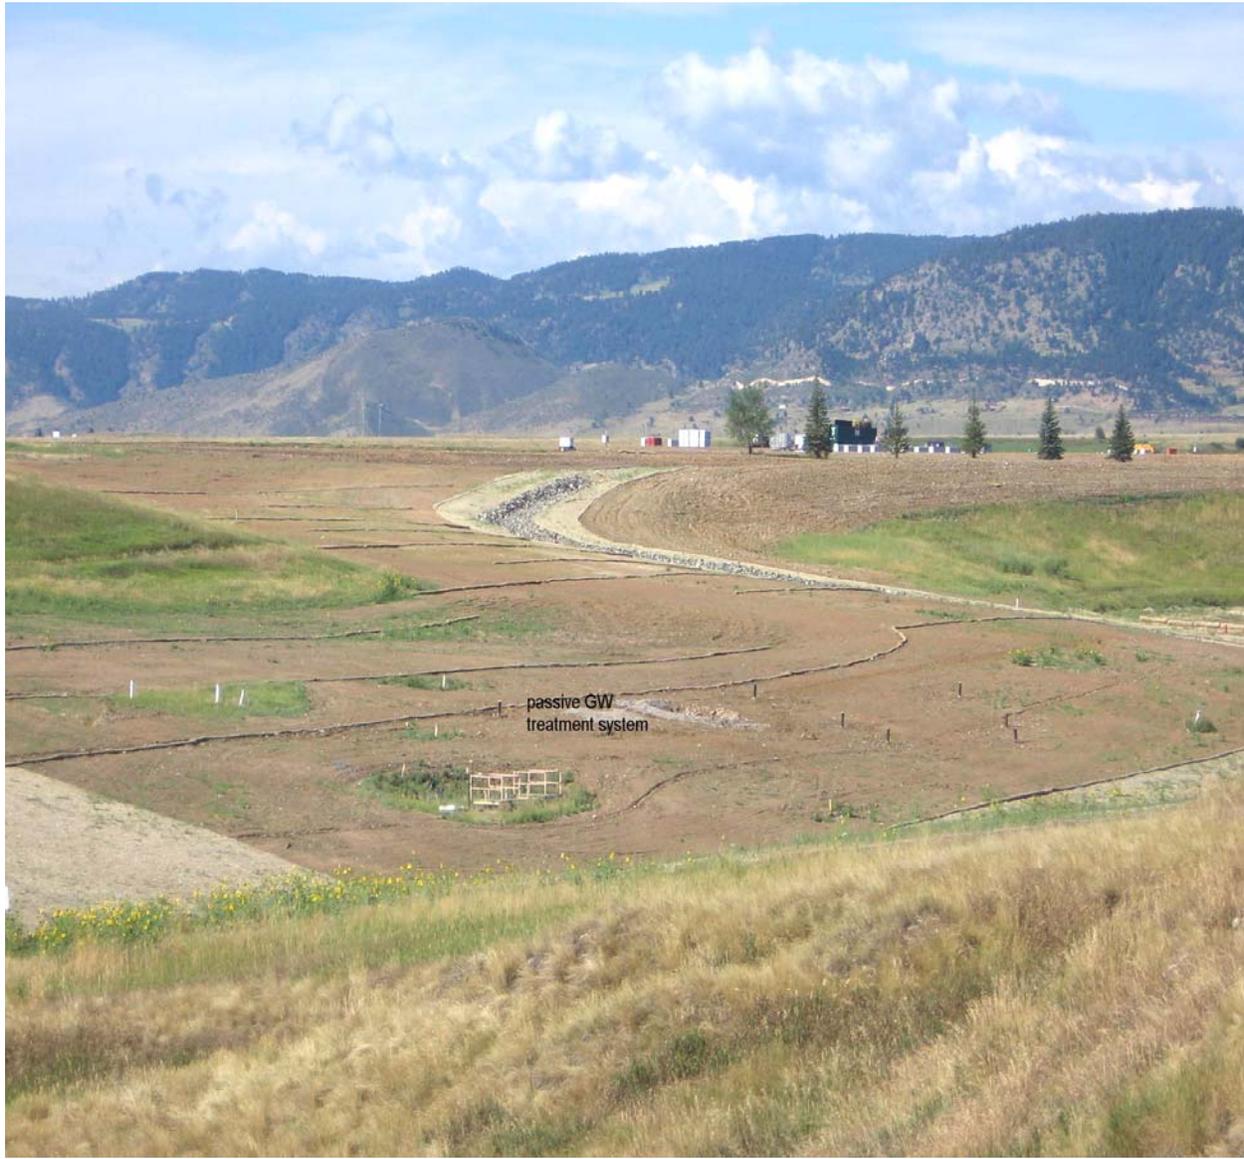
Figure 1. View looking southwest towards slope with Mound Site Passive Groundwater Treatment System and ground water monitoring wells (August 2005)

Based on the threat to surface water in the South Walnut Creek drainage by emerging contaminated groundwater from the Mound site, a passive groundwater treatment system was installed in the 1990s. Additional groundwater wells were installed around the treatment system to monitor its treatment efficiency and also determine the extent of the contaminated groundwater plume. Figure 1, page 4, is a photo from August 2005 showing the slope where the treatment system was installed and corresponding groundwater monitoring wells. The passive treatment system will need to function well into the post-closure future of the site. The treatment cell media in the system have to be inspected and replenished on a periodic basis. In addition, the solar-powered sump pump in the collection area needs to be maintained for the treatment system to function.
